HOW BAD IS BAD:

A Novel Approach To Evaluating
Geohazard Risks Along Watercourses

Diana Friesen, Town of Oakville
Heather Amirault, Stantec Consulting Ltd.
March 25, 2021

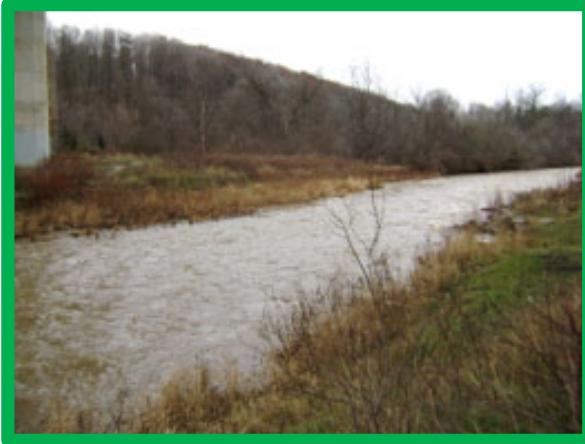
Class I - Floodplain downstream from Dundas St

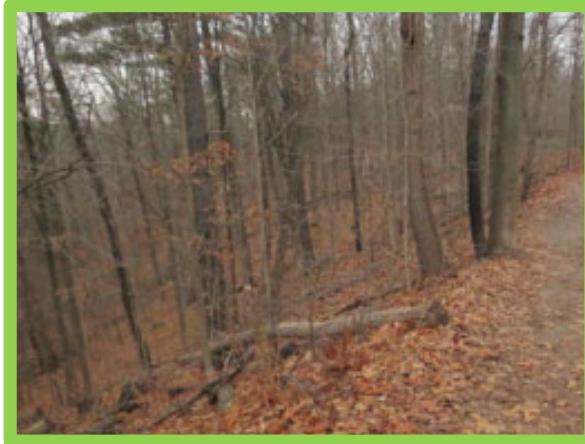
Class II - Trail near Winding Creek Cove

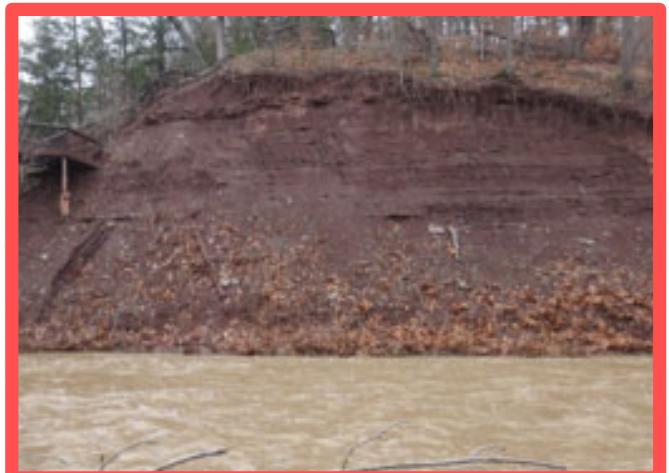
Class V - Slope adjacent to trail near Winding Creek Cove

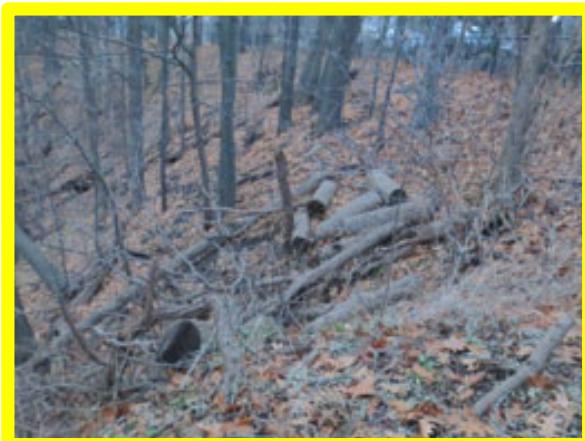
Class III - Slope adjacent to Bronte Rd

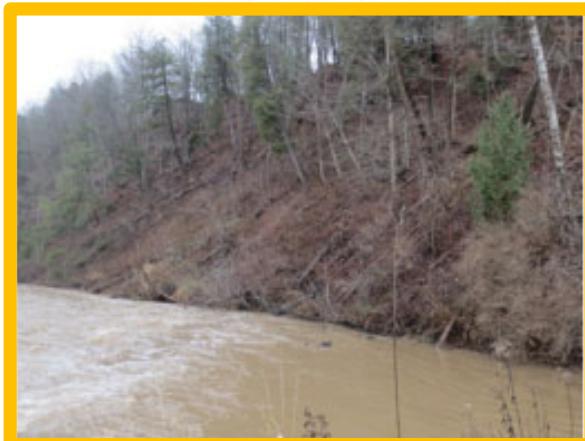
Class IV – Slope site S-002

| Landslide Hazard Class | V | IV | III |
|---|---|---|---|
| S-002 | | 45 | |

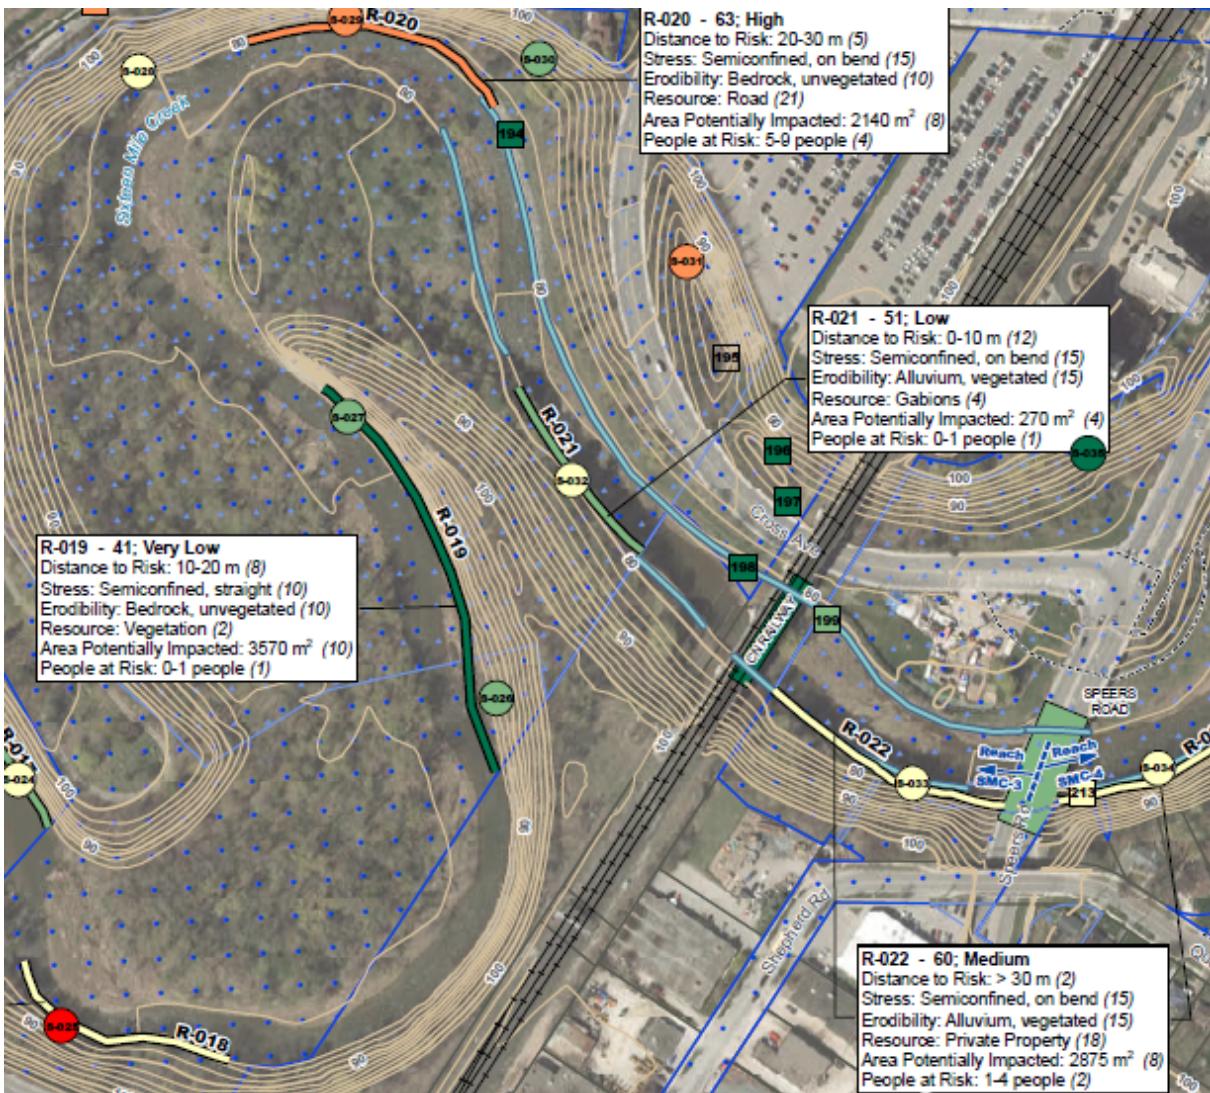
R-022 - 60; Medium

Distance to Risk: > 30 m (2)

Stress: Semiconfined, on bend (15)

Erodibility: Alluvium, vegetated (15)

Resource: Private Property (18)

Area Potentially Impacted: 2875 m² (8)

People at Risk: 1-4 people (2)
