# Glendale Public School Rain Garden: Design and Build Overview

## EXECUTIVE SUMMARY

### Design Objectives and Key Outcomes

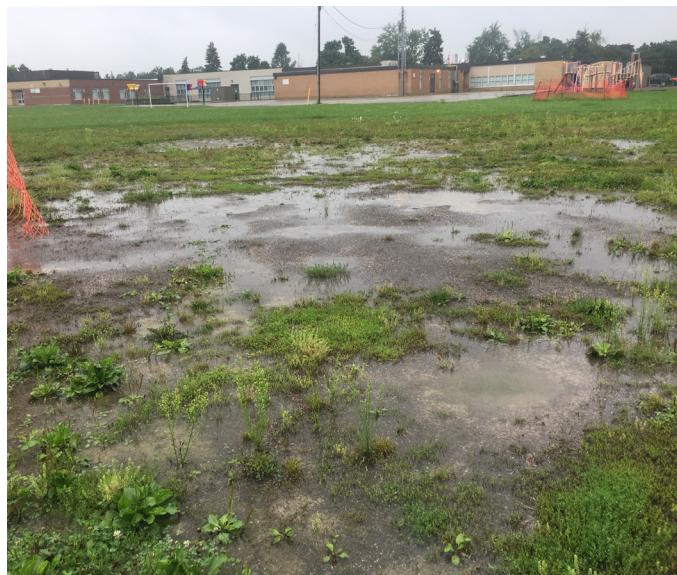
Figure 2. Pre-existing site drainage problems

1. Address existing drainage concerns, especially on the old baseball diamond and around the edge of the asphalt play area behind school.
2. Improve water quality in Fletchers Creek by treating stormwater runoff on school property.

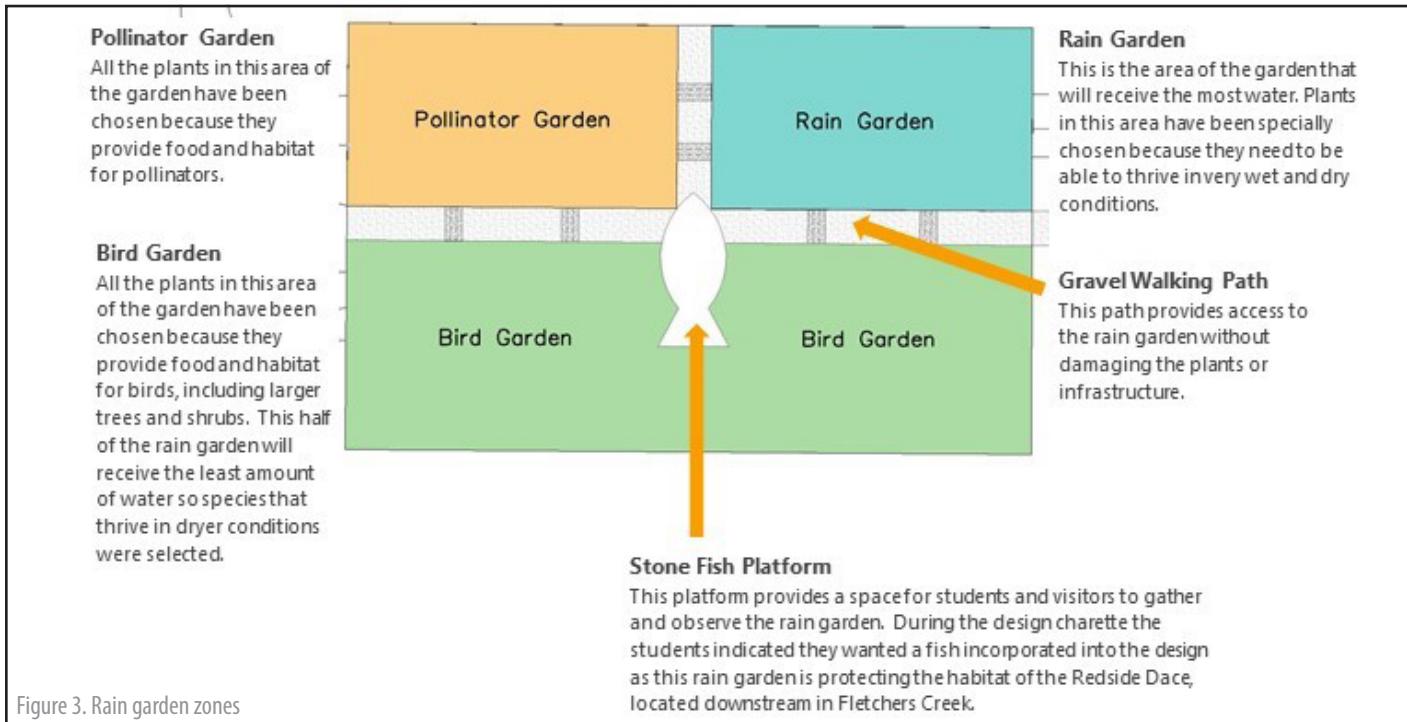
Figure 3. Rain garden zones

The design concept for a rain garden that would address the drainage issues on site and water quality issues in nearby Fletchers Creek was developed by CVC in collaboration with Ecosystem Recovery Inc., Into The Woods and City of Brampton staff. After an initial site visit, a “treatment train” approach was taken and included the following features (Figure 3 and 4):

3. The garden would include three (3) distinct sections:
  - a. The first section (rain garden) would receive the most drainage and therefore plants were selected that can thrive in very wet and dry conditions.

- b. The second section (pollinator garden) would include plants that would provide food and habitat for pollinators.
  - c. The third section (bird garden) would include larger plants, such as trees and shrubs, that will provide food and habitat for birds.

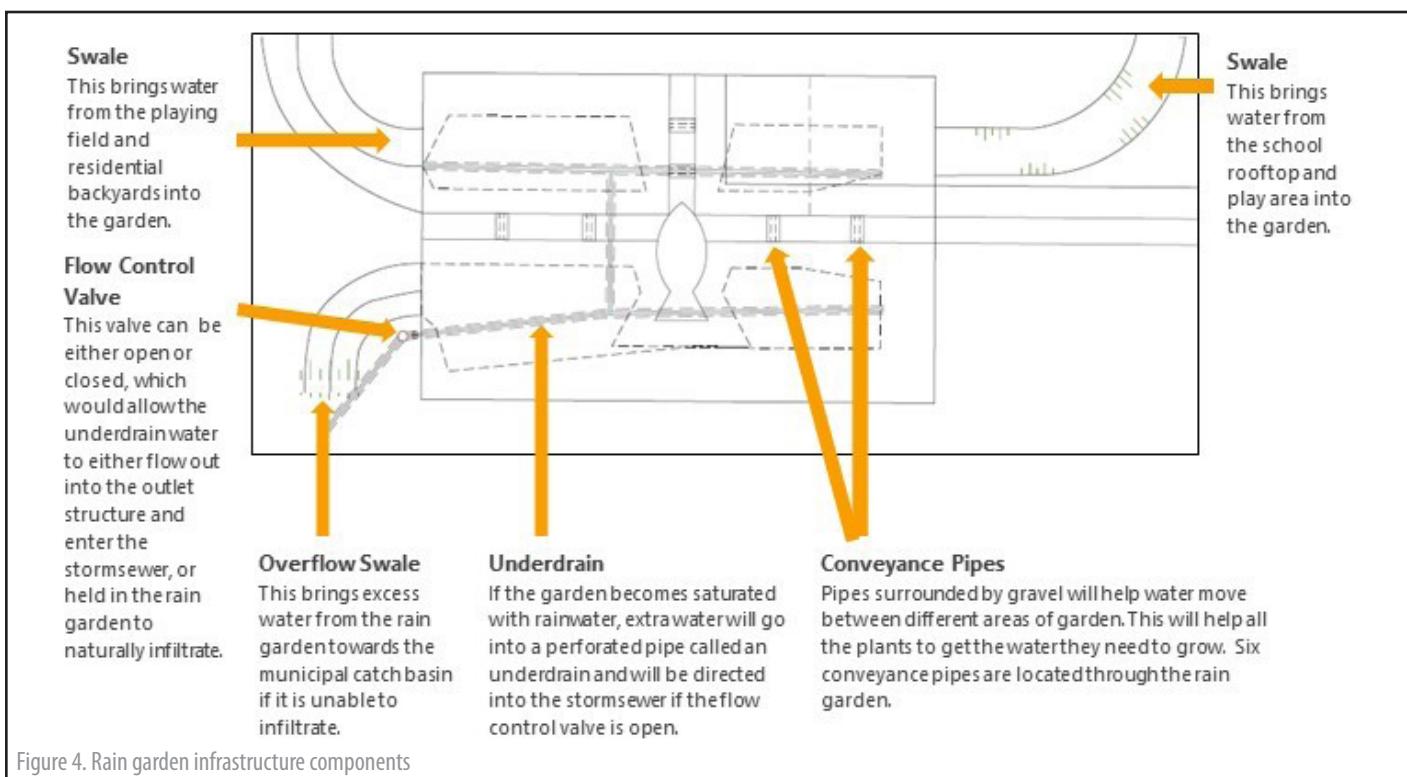
Figure 4. Rain garden infrastructure components

1. Swales would direct surface runoff from the pavement and surrounding field towards a rain garden.
2. A rain garden would be placed in the southern corner of the property, removing an old unused baseball diamond where the elevation is lowest. This feature would incorporate trees, shrubs and native plantings as well as soil amendments and micro-topographic features to encourage infiltration and support plant growth.

4. Pathways would be created to allow students, staff and community members to access the naturalized area. Drain pipes under the pathways would allow the water level to equalize between garden cells.

5. Perforated underdrain pipes, placed under the planted area, would be used to drain the facility.

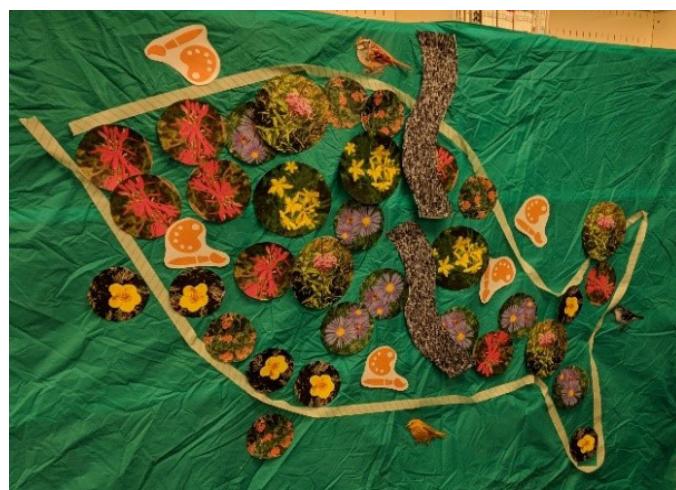
Figure 5. Design charette results

A design charette was held with students from Glendale P.S. where choices for the shape of the garden (Figure 5), the plants used, and the amenities included were selected. Some of the results of the design charette are provided in Table 1.

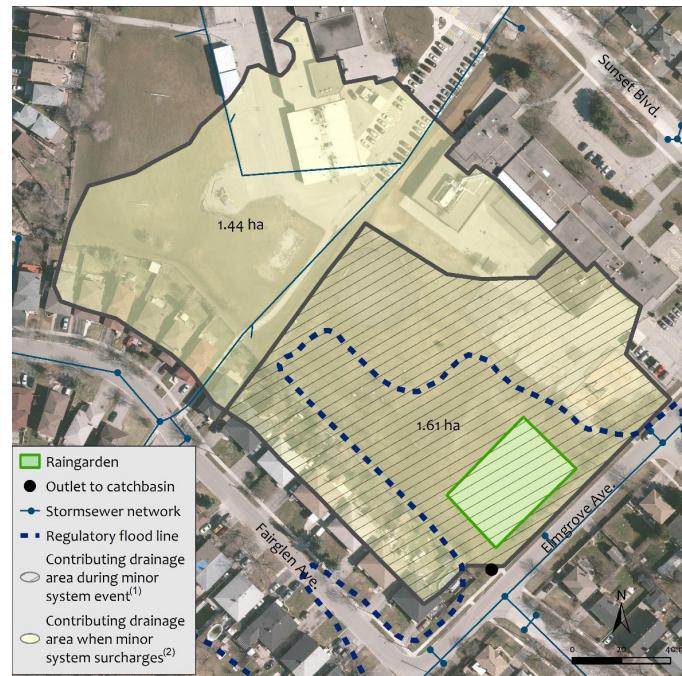
Figure 6. Study area

Through analysis of the site it was decided that the garden would be placed in the southern corner of the property to be able to capture most of the runoff from the site (Figure 6). The surface area available according to the topographical and physical infrastructure constraints was 965m<sup>2</sup>. The total drainage area during a minor system event is 1.61ha (the hatched area in Figure 6). Of this drainage area, 29% is impervious. For larger storms that cause the minor system to surcharge, the total drainage area is 3.05ha (1.44ha + 1.61ha). The garden was designed to capture at least 27mm of rainfall from the 1.61 ha, which translates to 200m<sup>3</sup>. The maximum volume that can be retained by the garden is around 210m<sup>3</sup>, exceeding the minimum requirement.

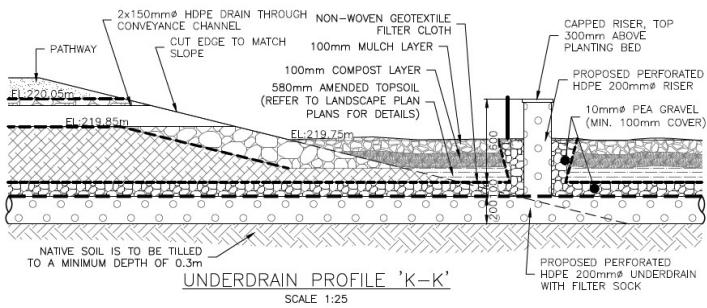
Figure 7. Underdrain and overflow riser detail

A flow control valve would be placed at the underdrain outlet of the facility to control the amount of water draining from the garden into the municipal system located on Elmwood Avenue. During normal operation, this valve would be closed to maximize storage and infiltration into the native soils. Under extreme rainfall events the valve can be opened to release water. Even with the valve closed, the system would still have a back up overflow weir into the municipal system.

soil infiltration rate was determined to be approximately 15-20mm/hr. The garden was designed to have a maximum surface ponding depth of 300mm above the surface of the naturalized area (see Figure 7 for overflow structure) which is within the values recommended by the LID SWM Planning and Design Guide Wiki (STEP 2019). The ponded water would drain down over a maximum period of 30 hours (using a factor of safety of 2, the infiltration rate would be 10mm/hr), which is less than the recommended amount of 48 hours in the LID SWM Planning and Design Guide Wiki.

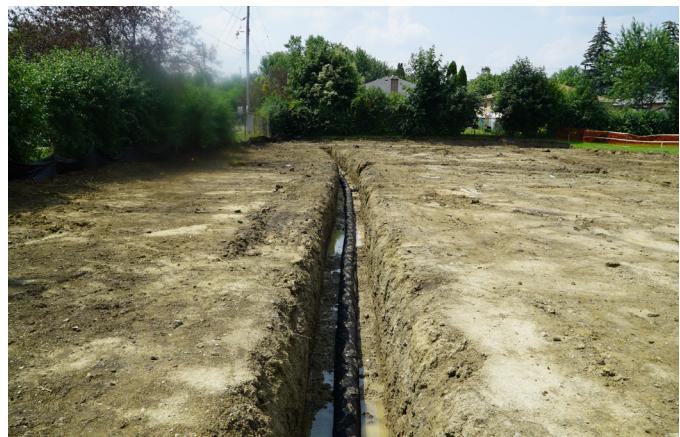
Figure 8. Vegetation removed, underdrain trench excavated

Construction of the rain garden took approximately two months to complete. The initial step was to remove existing vegetation, sod and topsoil from the rain garden site, which included the removal of an old baseball diamond. After the site was cleared, ditches were excavated for the underdrain pipes (Figure 8) followed by the installation of infrastructure including cleanouts, monitoring wells, overflows and the outlet catchbasin. The bioretention area was further excavated then graded along with conveyance pipes (connecting pipes between rain gardens) being put in place.

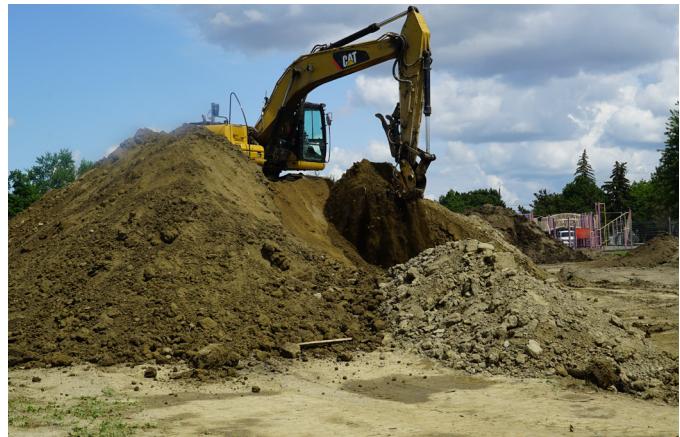
Figure 9. Soil amendment

Once this work was completed, some of the native top soil (initially piled in the nearby yard) was mixed with compost and horse manure to increase the organic content, allowing for increased absorption and infiltration, and the rain garden area was filled with this mix (Figure 9). The remaining soil was spread on the land adjacent to the rain garden (outside of the regulated floodplain) and hydroseeded. Pathways and a fish shaped platform in the middle of the rain garden were built (Figure 10). A flow control valve was placed at the underdrain outlet to control the amount of water draining from the garden into the municipal system (Figure 11). The connecting overflow swale from the rain garden catchbasin outlet (Figure 12) to the storm sewer was constructed and covered with grass (Figure 4).

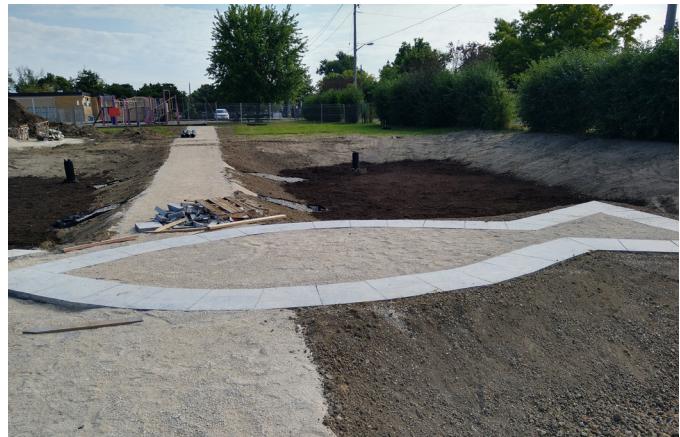
Figure 10. Laying the pathway and fish outline

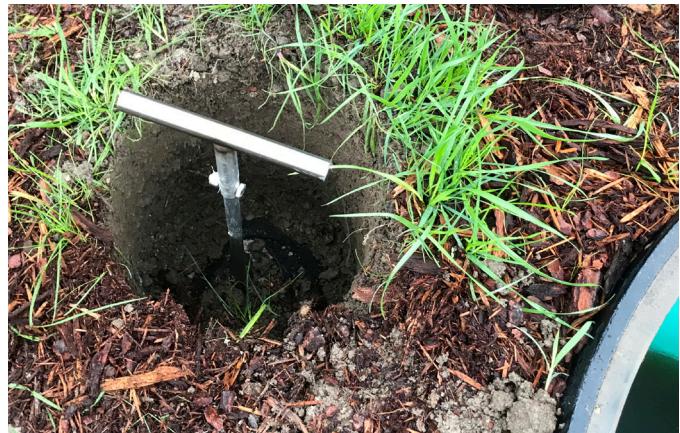
Figure 11. Control valve

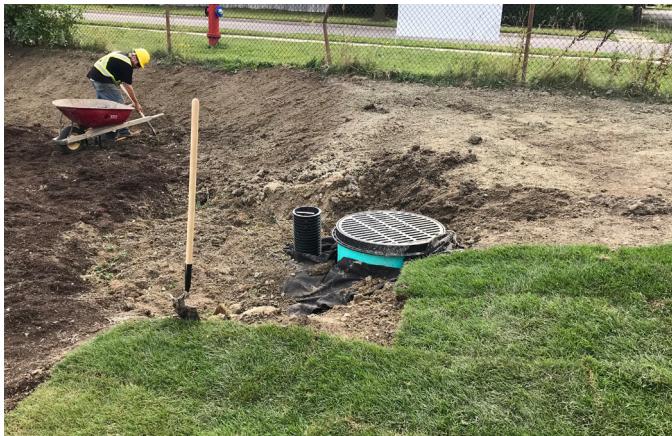
Figure 12. Rain garden catchbasin outlet

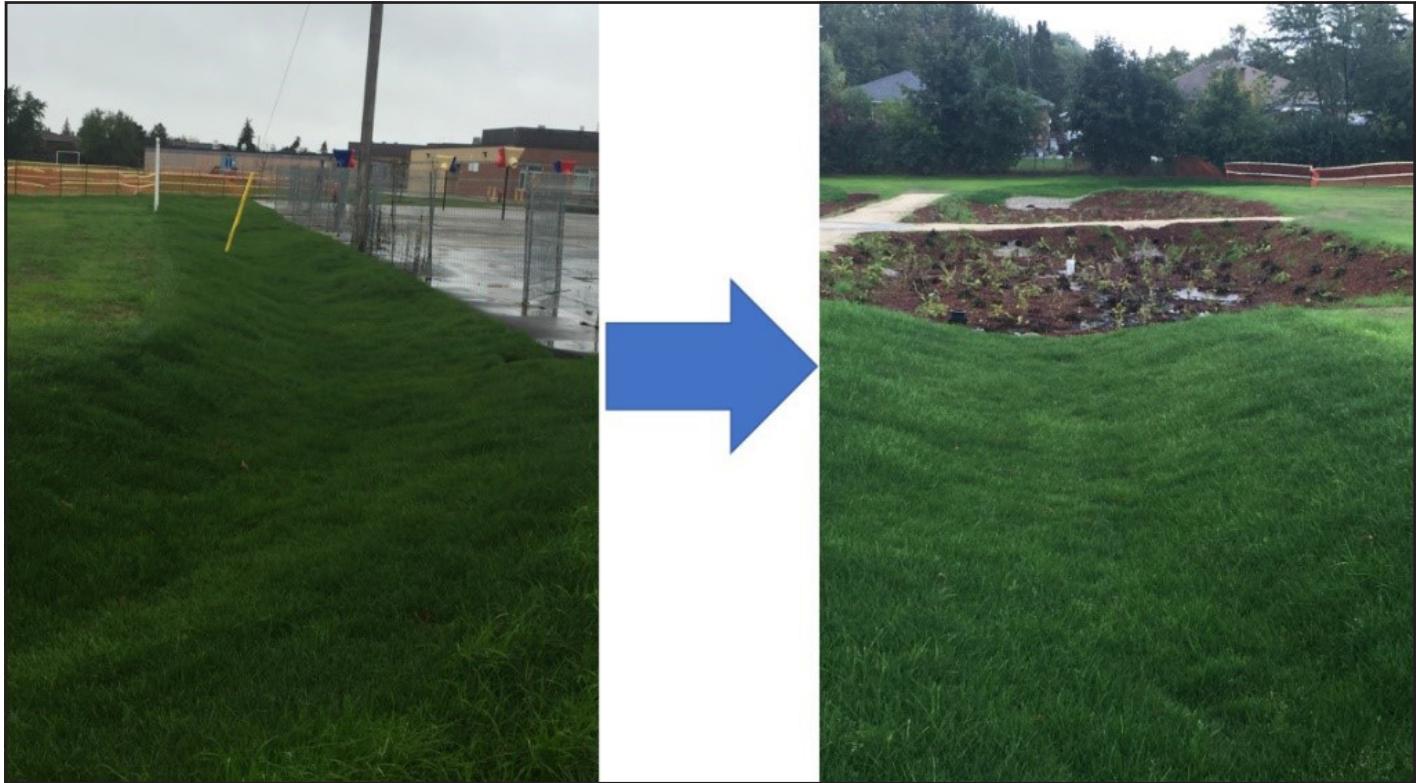
Figure 14. Conveyance of sheet flow via grass swale to the cell of the rain garden

Once the garden was operational, observations were made following a 25mm-rainfall event in October 2019. Sheet flow over the impermeable pavement was successfully conveyed to the rain garden through the grass swale (Figure 14). There was some ponding on the surface of the receiving cell (Figure 15) while no water ponding was observed in the pollinator and bird garden sections. All the connecting pipes were monitored to ensure they allowed for clear water flow. Using the cleanout points as an observation port, flow was also observed in the perforated underdrain pipes, confirming successful performance. Monitoring the flow paths through the garden outlet to the catchbasin, which ultimately drains to the City's sewer network is also

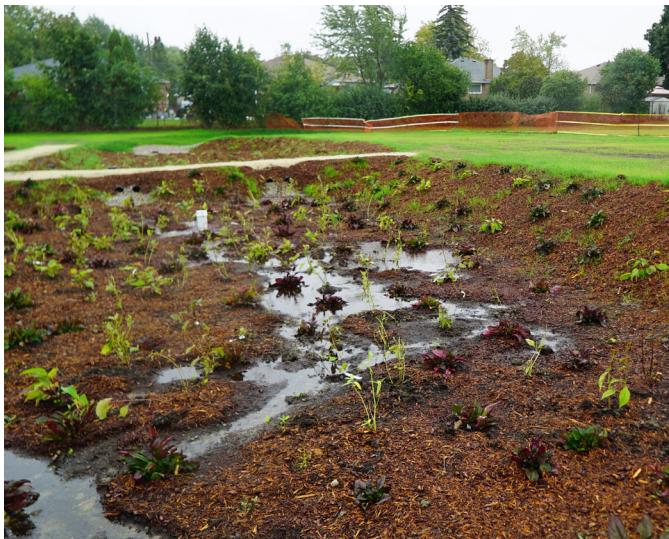
Figure 15. Ponding water over the surface of the first cell of the rain garden

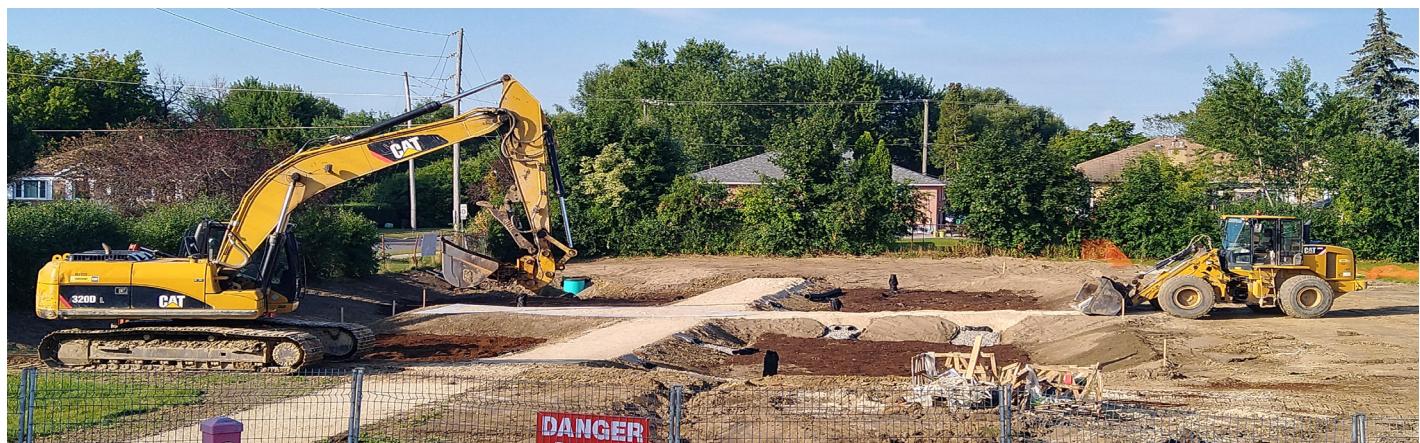
Figure 16. Glendale rain garden during construction
