HOW BAD IS BAD:

A Novel Approach To Evaluating
Geohazard Risks Along Watercourses

Diana Friesen, Town of Oakville
Heather Amirault, Stantec Consulting Ltd.
March 25, 2021

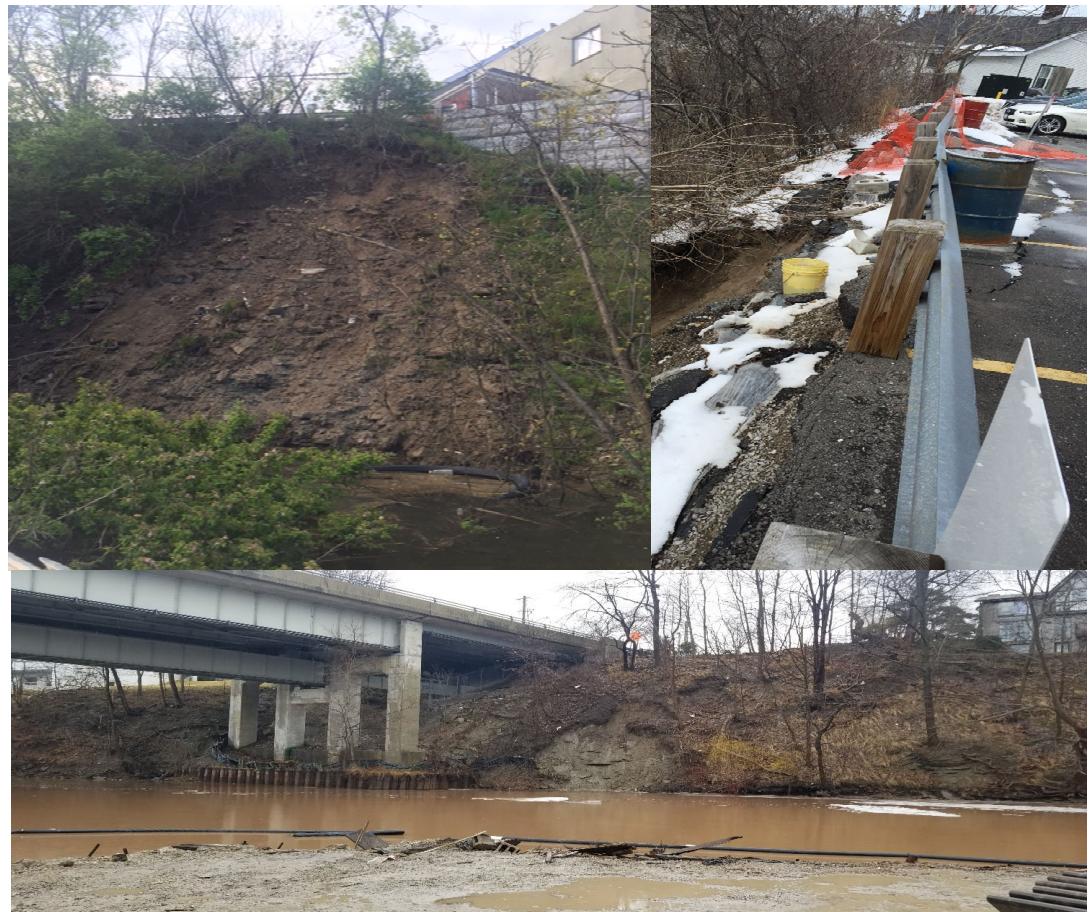
- In 2017, above average wet spring conditions resulted in saturated conditions causing slope failure in areas along the valley corridor.

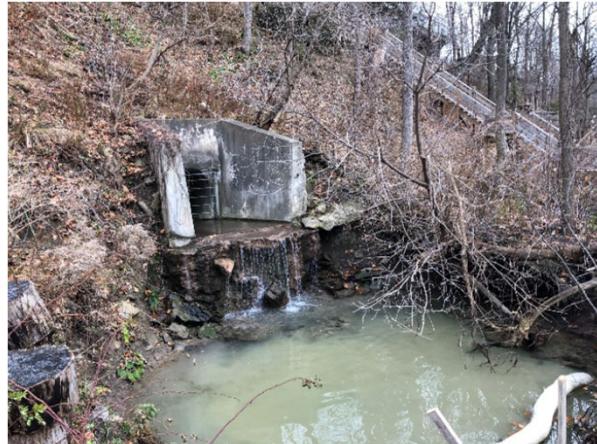
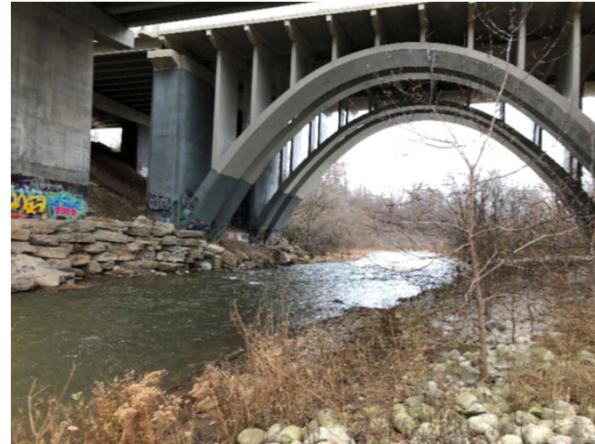
- Study also reviewed the conditions of stormwater outfalls and crossing infrastructure
- Made recommendations from monitoring / routine maintenance to priority maintenance
